**Flood Control Project Maintenance
Levee Inspections**
LMA District Cover Sheet
Spring 2009 Levee Inspection Results

Reclamation District No. 2095

Levee Inspection Report By Mile - Spring 2009

Waterway	Bank	Unit Miles	Inspection Start/End	Inspector
Unit No. 01 Paradise Cut	Left	1.50	04/21/2009 04/21/2009	Richard Willoughby

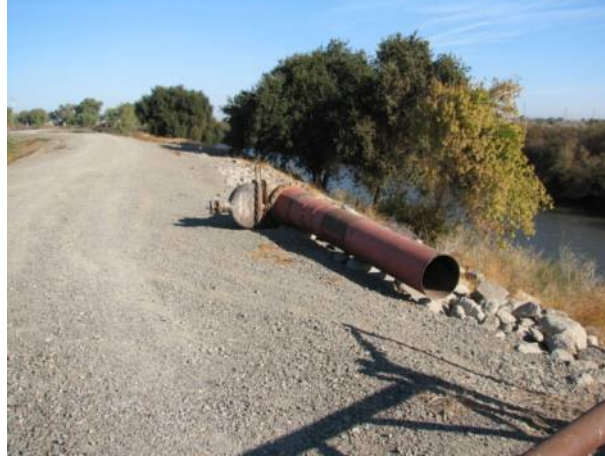
Levee Mile Report Line	4
Start Levee Mile	0.88
End Levee Mile	0.88
Location	Water Side
Category	Earthen Levee
Item	Encroachments
LM .88 RD 2095 unit 1 Paradise Cut. Pipe on WS should be removed. Failure to do so may encourage, simply by example, additional equipment to be left on the levee for 'later' removal.

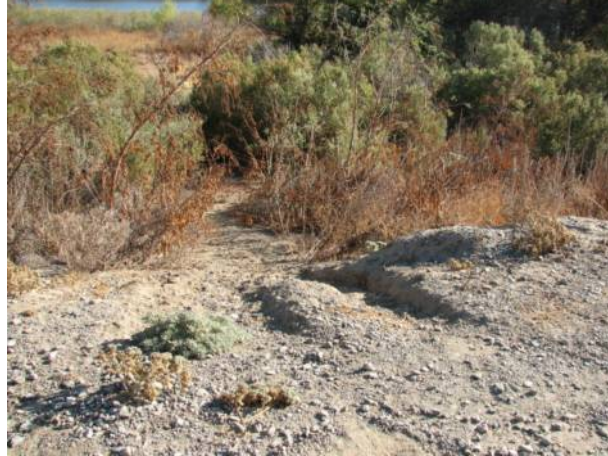
Levee Mile Report Line	5
Start Levee Mile	0.14
End Levee Mile	0.14
Location	Water Side
Category	Earthen Levee
Item	Erosion / Bank Caving

RD 2095 unit2. WS bank caving at LM 0.14.

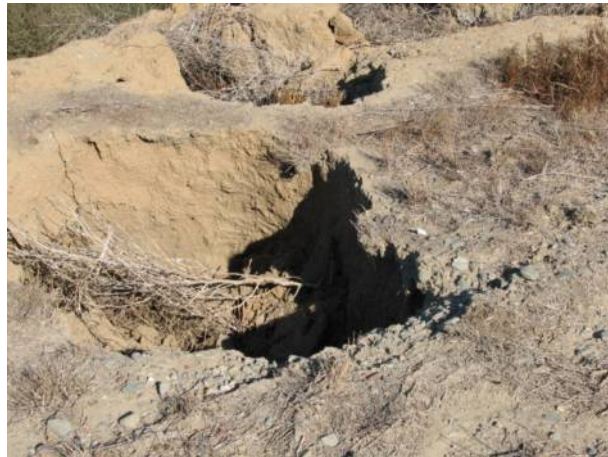
Levee Mile Report Line	19
Start Levee Mile	1.81
End Levee Mile	1.81
Location	Land Side
Category	Earthen Levee
Item	Erosion / Bank Caving

RD 2095 unit2. LS caving, quite large. Should be repaired ASAP. Possible threat especially during any flood fight attempt in this area.

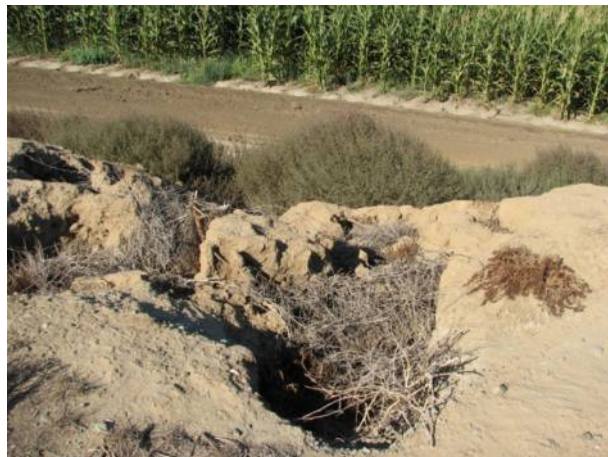
Levee Mile Report Line	19
Start Levee Mile	1.81
End Levee Mile	1.81
Location	Land Side
Category	Earthen Levee
Item	Erosion / Bank Caving

Another view.

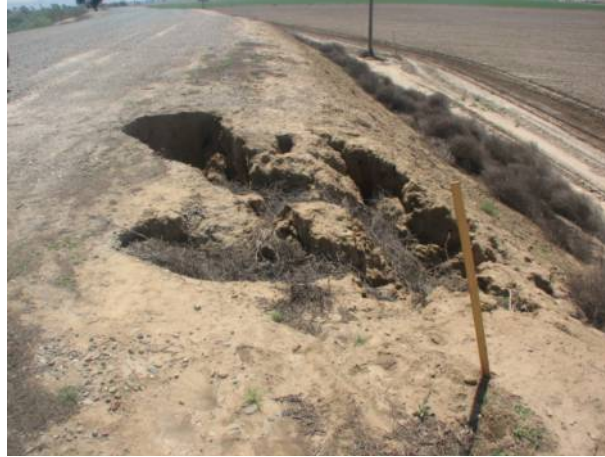
Levee Mile Report Line	19
Start Levee Mile	1.81
End Levee Mile	1.81
Location	Land Side
Category	Earthen Levee
Item	Erosion / Bank Caving

Looking upstream at erosion on landside shoulder and slope.

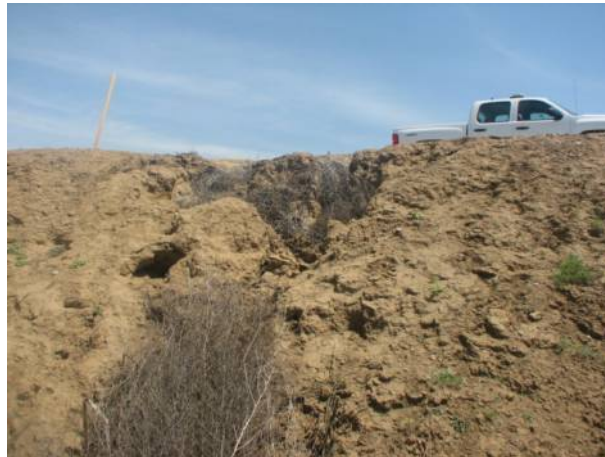
Levee Mile Report Line	19
Start Levee Mile	1.81
End Levee Mile	1.81
Location	Land Side
Category	Earthen Levee
Item	Erosion / Bank Caving

Looking at erosion from landside toe.

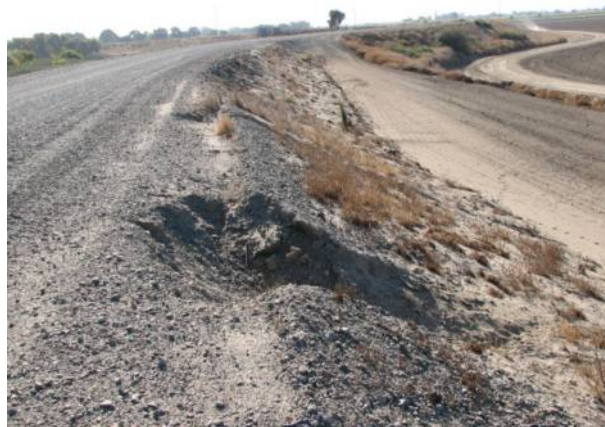
Levee Mile Report Line	24
Start Levee Mile	2.14
End Levee Mile	2.27
Location	Land Side
Category	Earthen Levee
Item	Erosion / Bank Caving

Rd 2095 unit 2. LS erosion and bank caving.

23	2.13	2.13	Earthen Levee	Encroachments	LS	M	Prunings	37.735273 ° -121.297855 °	37.735273 ° -121.297855 °		943
24	2.14	2.27	Earthen Levee	Erosion / Bank Caving	LS	M	Note and monitor erosion site.	37.735113 ° -121.297733 °	37.733210 ° -121.297253 °	Y	19
